# Manhole Inspection Summary

Manhole # S29K\_\_051MH

Insp Date: **4/9/09 1:48 PM**

**Location** Address: **MC HENRY ST**

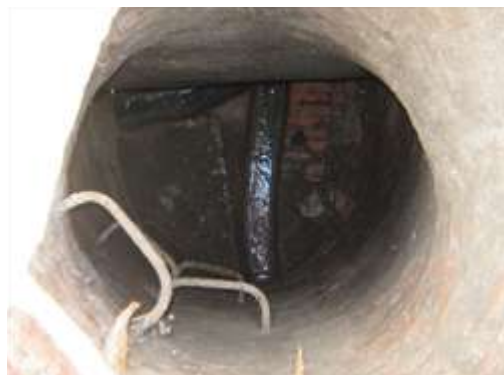
Top View

Unable to get 12:00 pipe connection in photo because of manhole design.

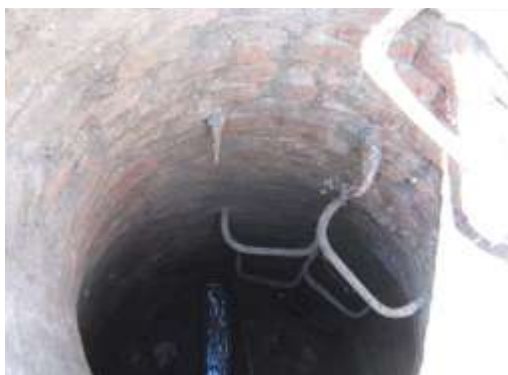
Miscellaneous

MH steps

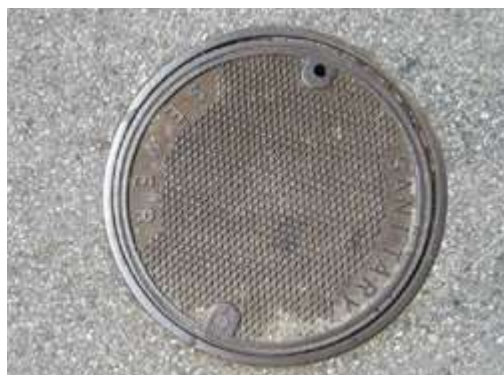
Miscellaneous

COVER PIC

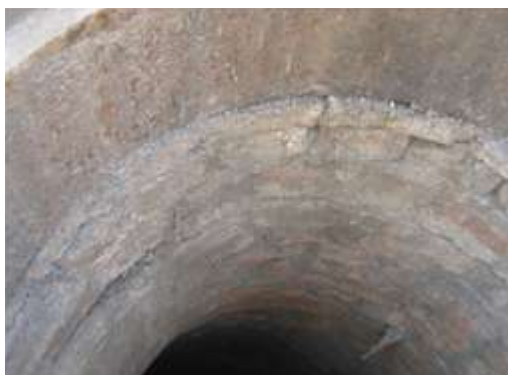
Defect 4

Condition: ☐ Sound ☐ Cracked ☒ **Leaks**

Condition: ☐ Sound ☒ **Cracked** ☐ Root Intrusion ☐ Loose Brick ☒ **Deteriorated**

LID/FRAE INFILTRATION, CRACKED AND DETERIORATING CHIMNEY

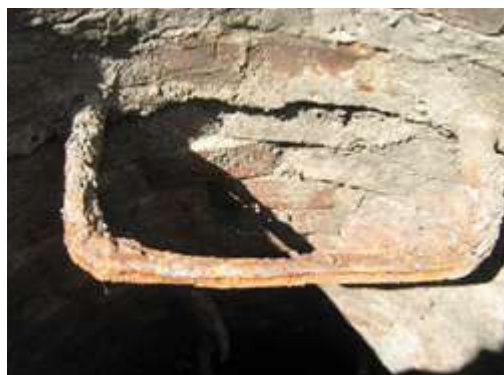
Defect 3

Count: **7** Missing: **1** ☒ **Corroded**

CORROED RUNG

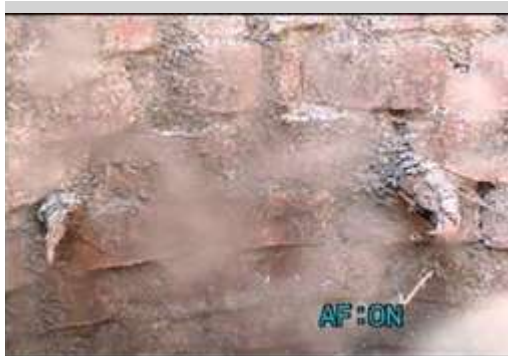
Defect 2

BROKEN RUNG

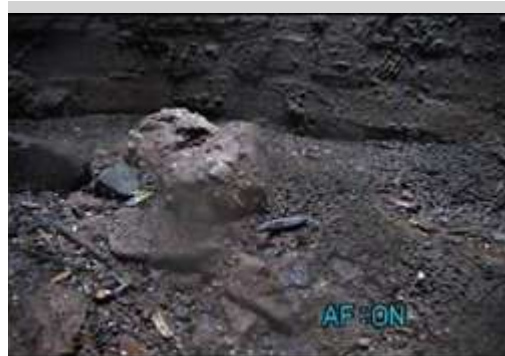
Defect 1

Condition: ☐ Sound ☐ Cracked ☐ Root Intrusion ☐ Deteriorated ☐ Leaks ☒ **Debris**

DEBRIS ON BENCH

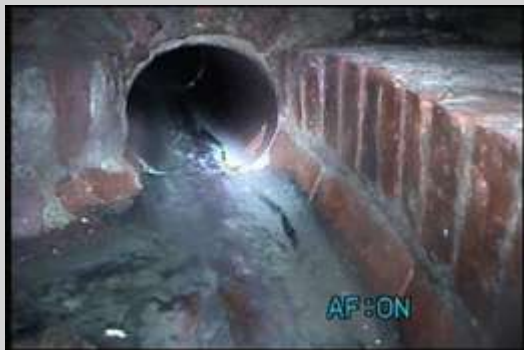
12 O'Clock Outflow

8 in. Circular Gravity Sewer  
Pipe Out @ 12 O'Clock

Infiltration: **None** Pipe Seal Cond: **Sound**

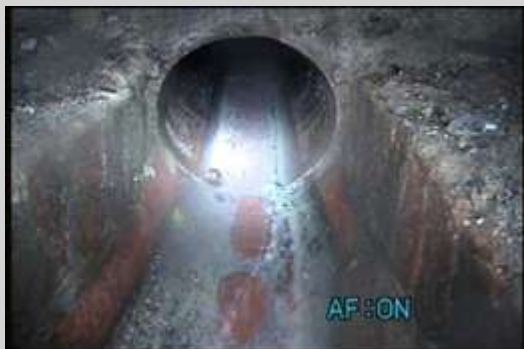
6 O'Clock Inflow

8 in. Circular Gravity Sewer  
Pipe In @ 6 O'Clock

Infiltration: **None** Pipe Seal Cond: **Sound**

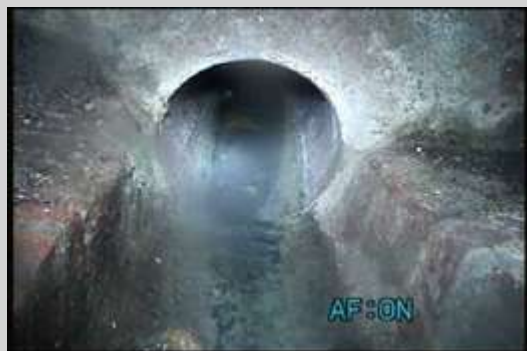
9 O'Clock Inflow

8 in. Circular Gravity Sewer

Pipe In @ 9 O'Clock

Infiltration: **None** Pipe Seal Cond: **Sound**
